Manhole Inspection Summary

Manhole # S37GG_014MH

Insp Date: **3/21/07 8:03 AM**

Location Address: **1500 GREENMOUNT AVE**

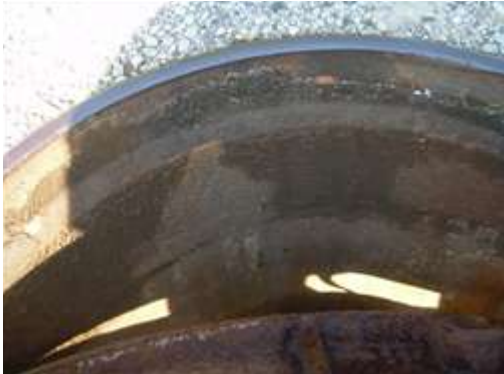
Defect

☒ **Leaks**

Frame leaks. Adjustment infiltration.

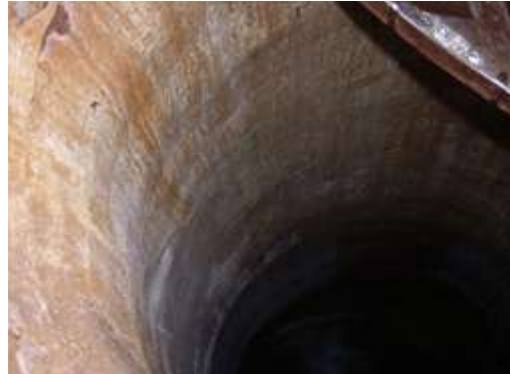
Defect

Infiltration: ☐ None ☒ **Joint** ☐ Cracks ☐ Mortar ☐ Roots ☐ Wall

Infiltration: ☐ None ☐ Joint ☐ Cracks ☐ Mortar ☐ Roots ☒ **Wall**

Corbel and Barrel infiltration.

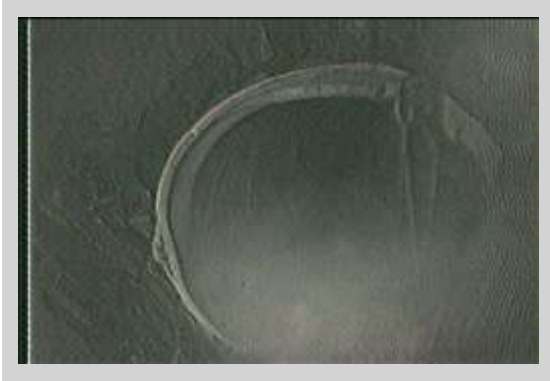
21 in. Circular Gravity Sewer Pipe Out @ 12 O'Clock

Rod and Bar (Angled)

Infiltration: **None** Pipe Seal Cond: **Unknown**

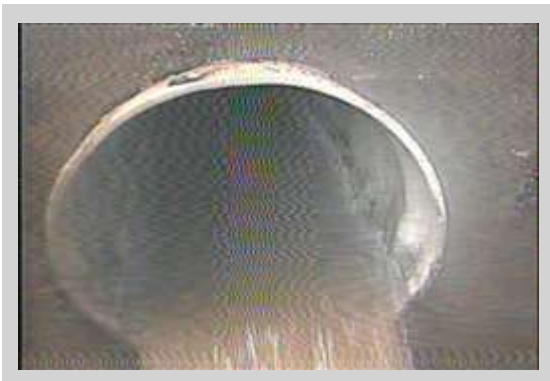
21 in. Circular Gravity Sewer Pipe In @ 5 O'Clock

Rod and Bar (Angled)

Infiltration: **None** Pipe Seal Cond: **Sound**
